ISCOR VANDERBIJLPARK STEEL

ENVIRONMENTAL MASTER PLAN

SPECIALIST REPORT

AQUATIC ECOSYSTEMS

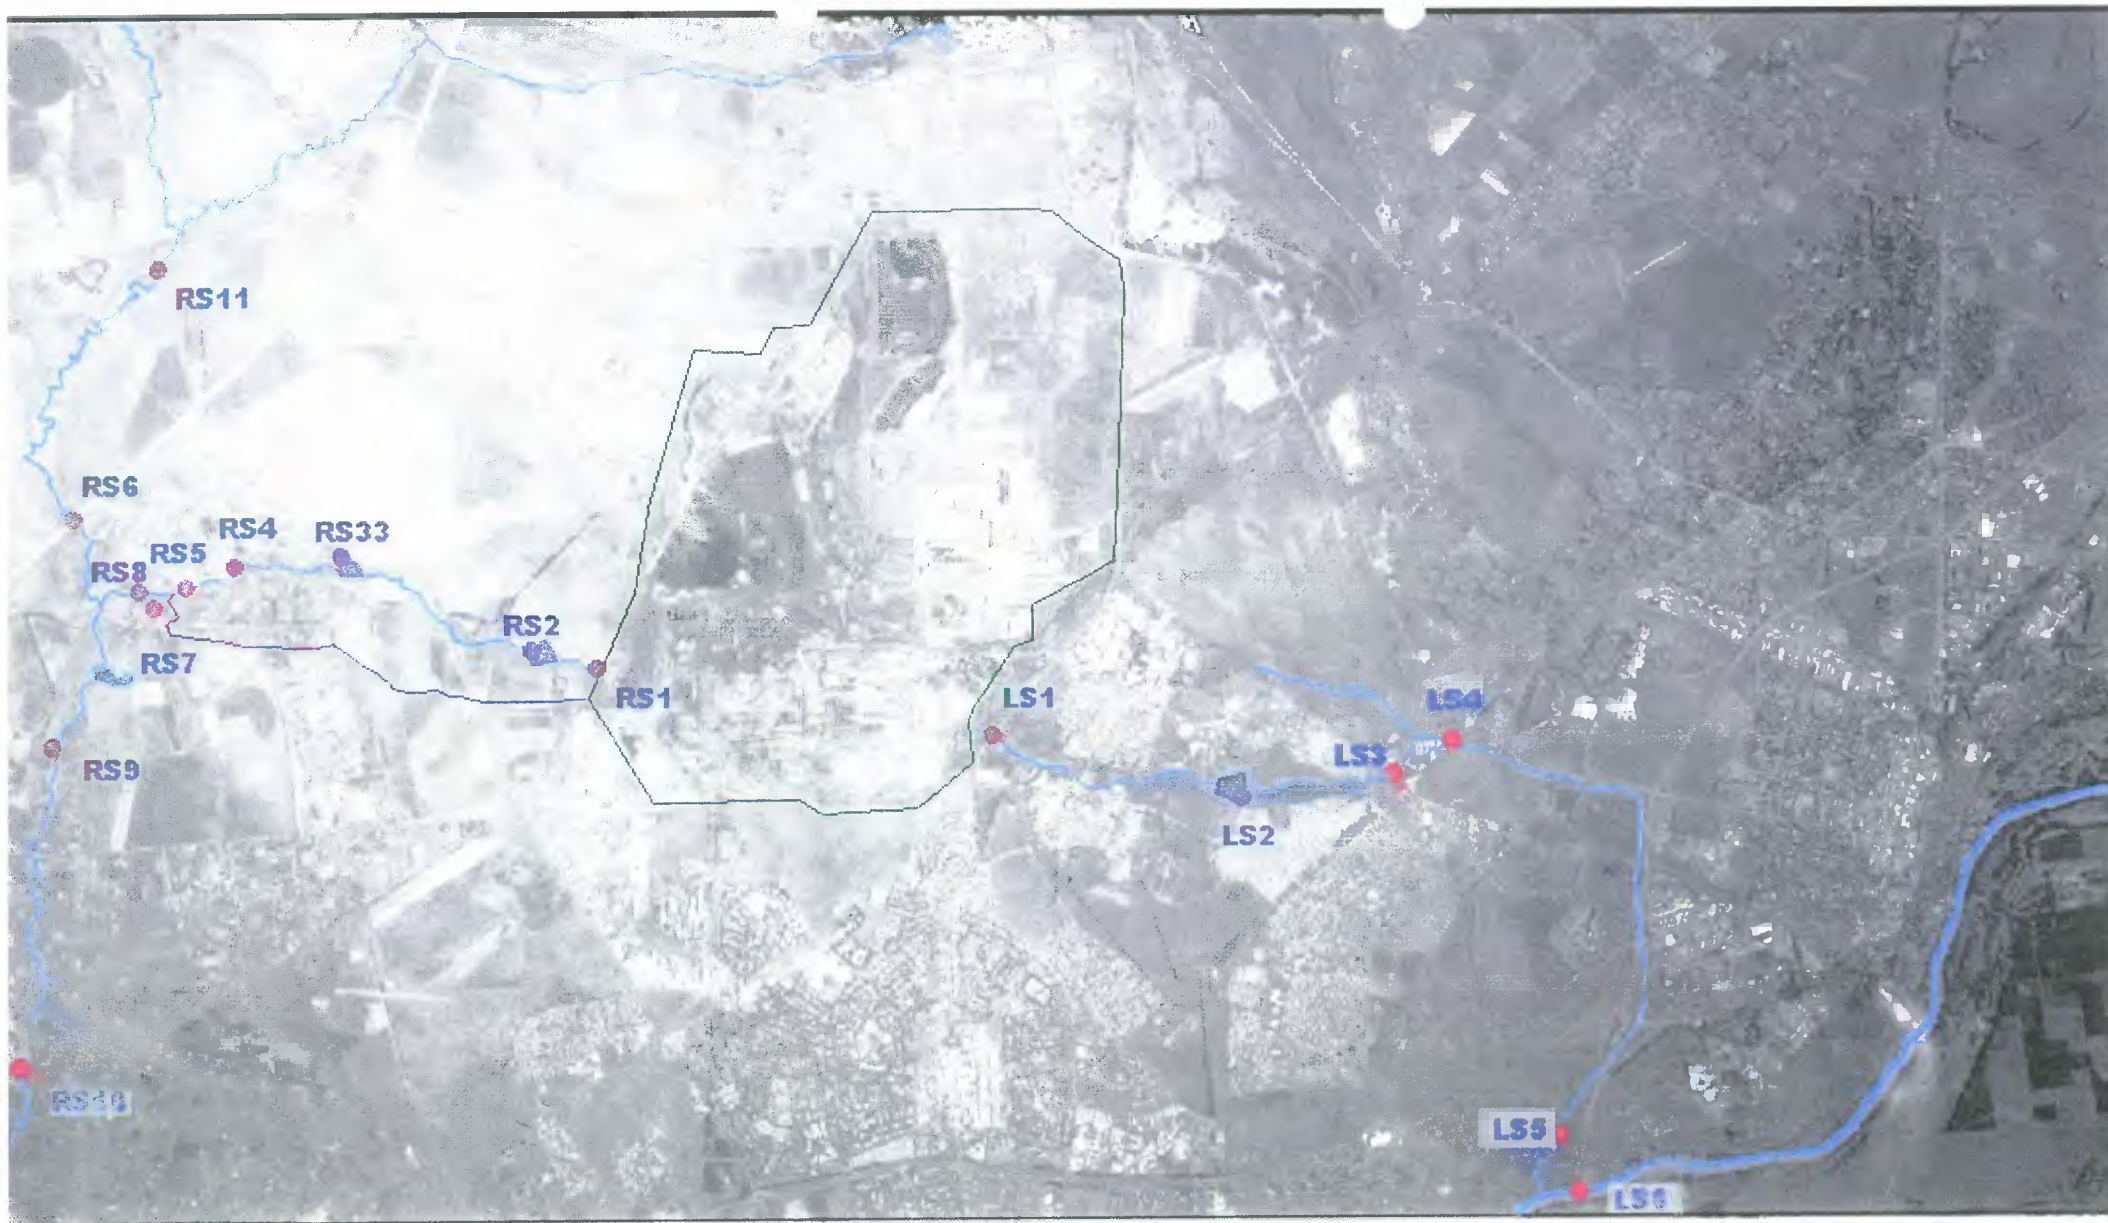
Figure 1: Sampling Sites in streams and rivers associated with the ISCOR Vanderbijlpark Plant

Sampling sites in the Rietspruit and Leeuwspruit were selected to coincide with existing water quality monitoring points and to include a suitable "natural" or "minimally impacted" reference site (Table 1 and Figure 1). Co-ordinates of sampling sites were determined using a Trimble Geographical Positioning System and are listed in Table 1. Photographs of sampling sites are presented in APPENDIX 1.

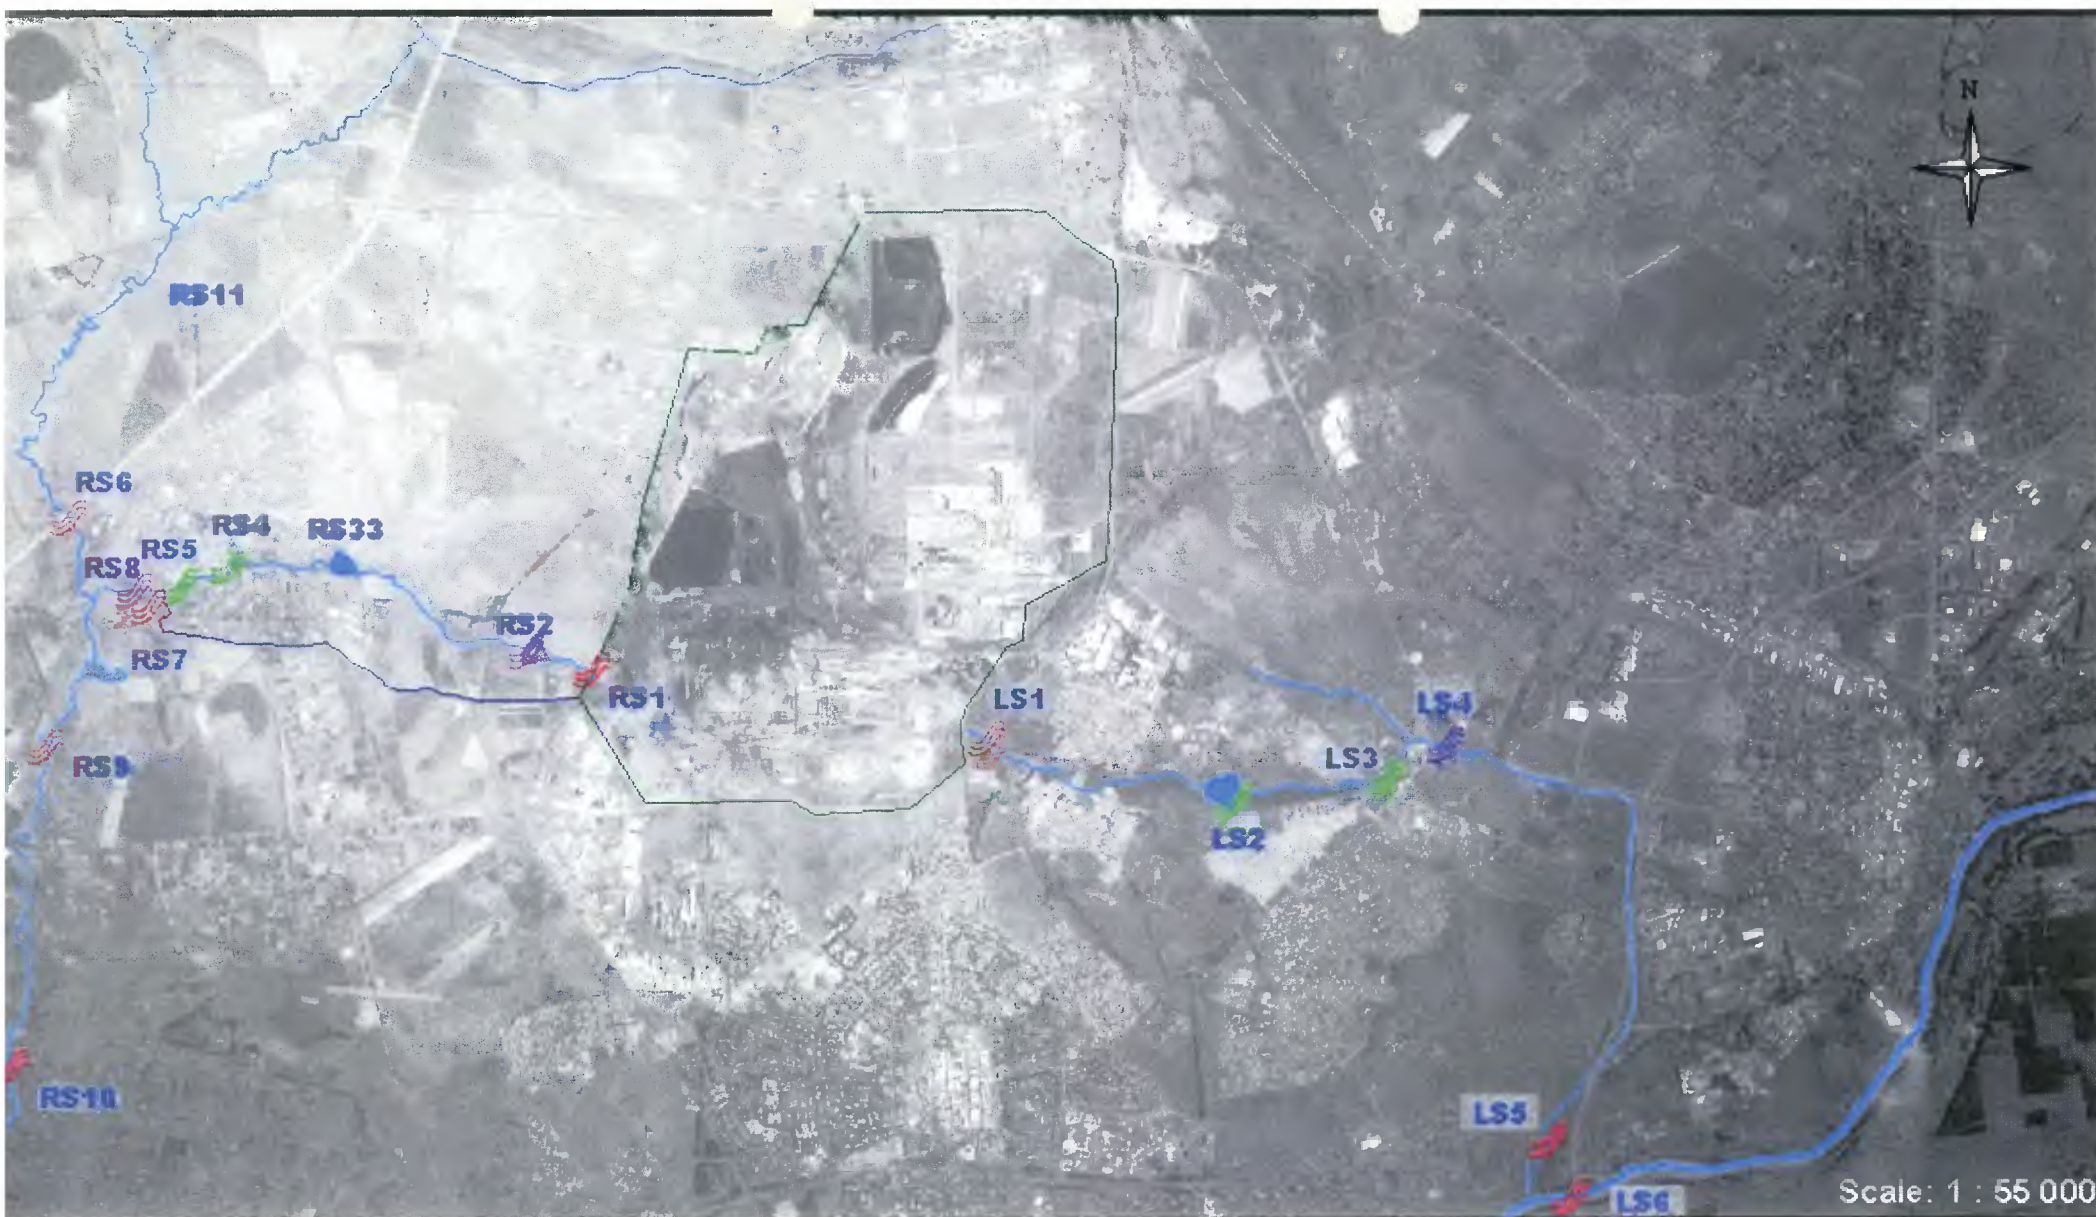
Figure 2: Habitat condition at selected sites in the study area, as reflected by the Integrated Habitat Assessment System (IHAS)

The habitat availability for aquatic macroinvertebrates was indicated to be good at the reference site in the Taaibosspuit (IHAS = 68%) (Table 9; Figure 2). Habitat availability was poor at sites RS1 and RS2 in the Rietkuilspruit, but improved towards sites RS4 & RS5 (good habitat availability), then decreased again at site RS8 (poor habitat availability) (Table 9). Habitat availability was poor in the Rietspruit, with IHAS values ranging between 24% and 37% (Table 9). IHAS scores in the Leeuwspruit varied between 29% and 67%, indicating poor to good habitat availability (Table 9; Figure 2).

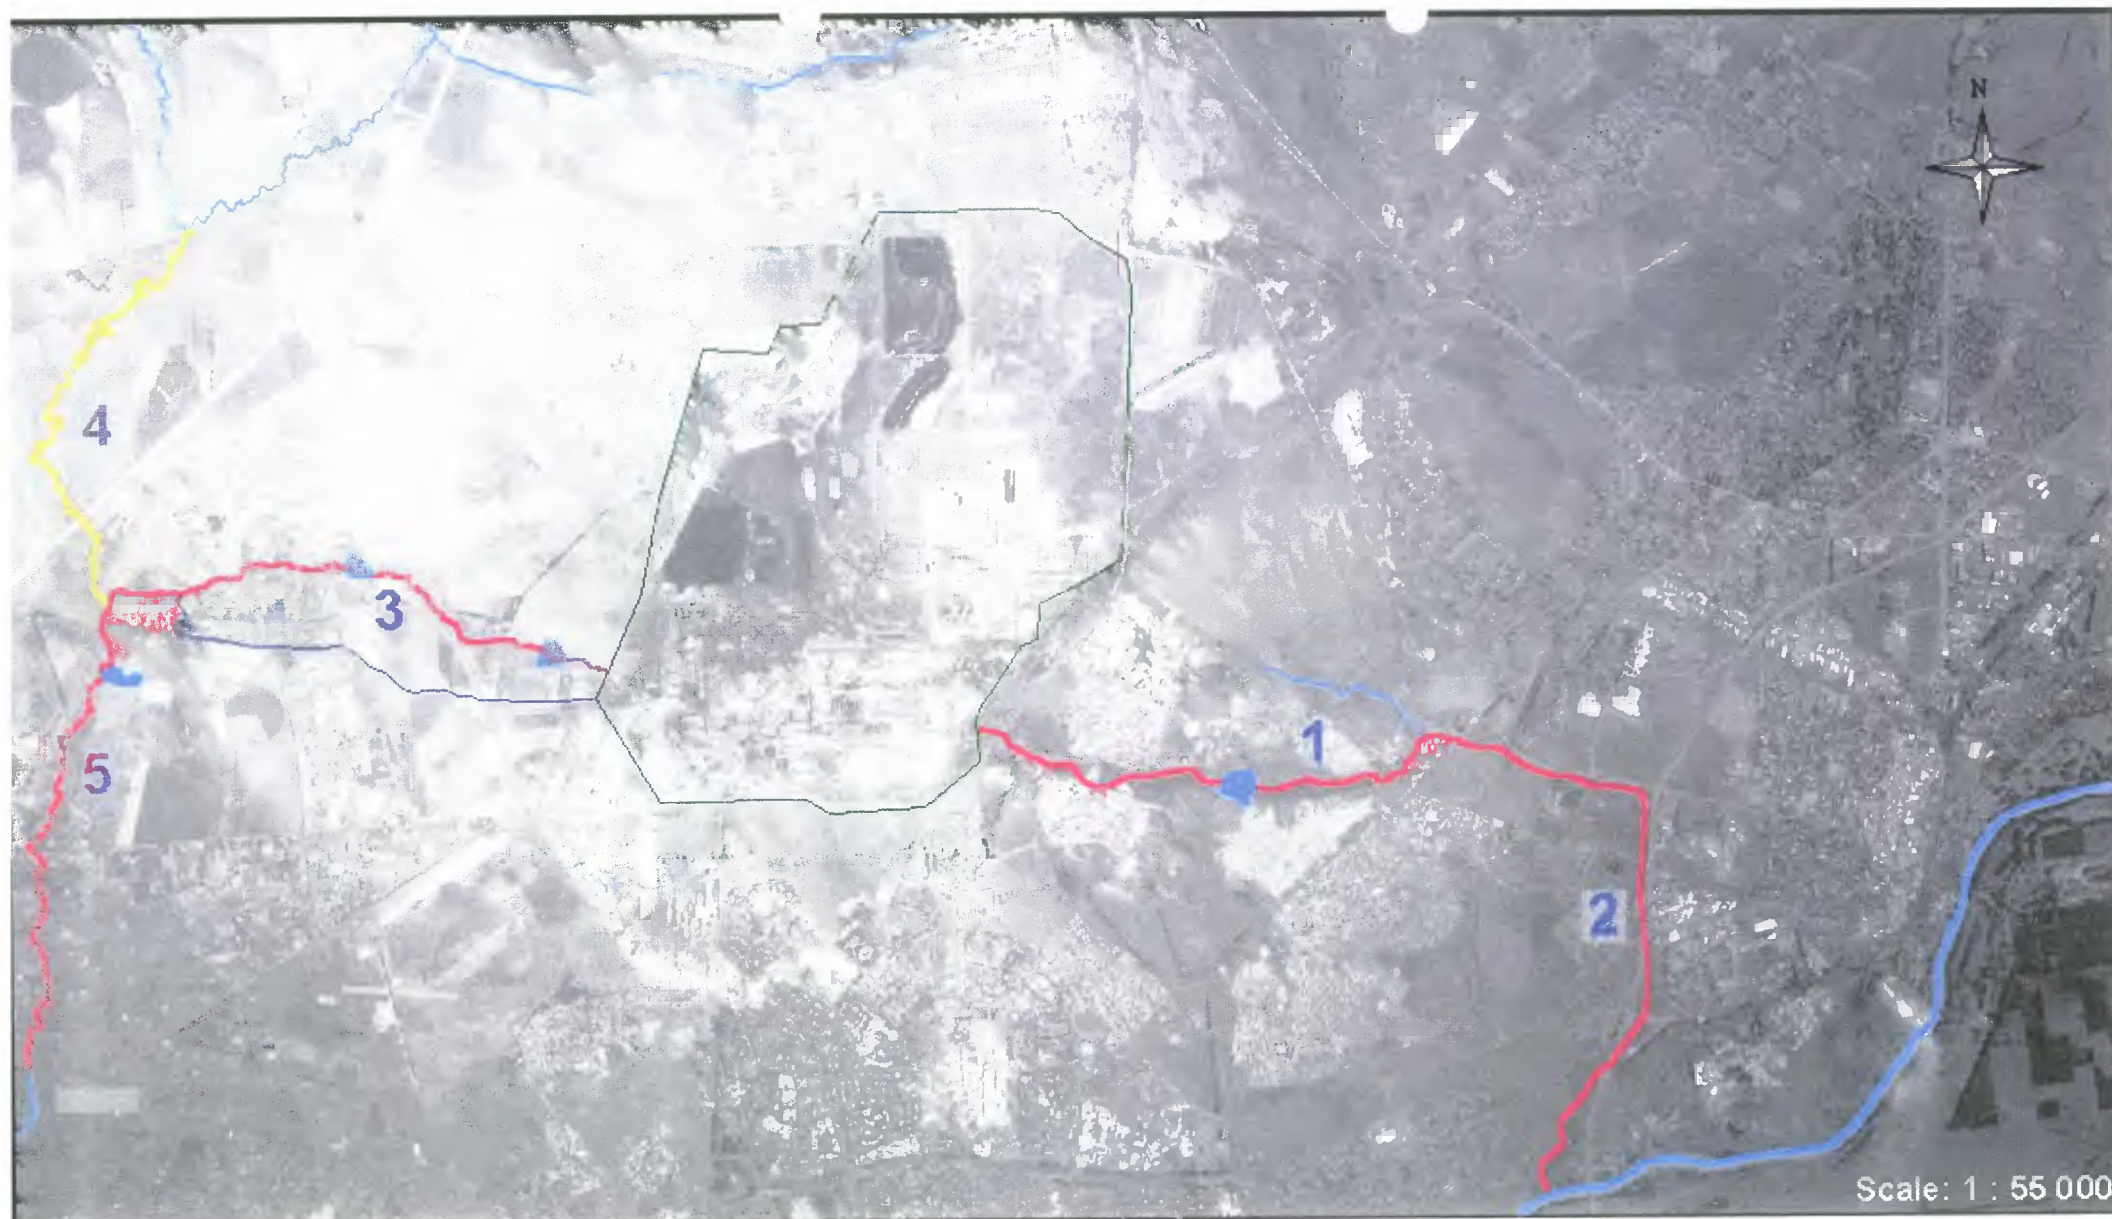
Figure 3: In-stream and Riparian Habitat Integrity of selected rivers/ streams in the study area

Segment 5 (Rietspruit): This segment constitutes a 5km reach of the Rietspruit downstream from the Rietkuilspuit confluence. Several factors impact upon Habitat Integrity in this river reach. These mainly include flow modification, bed modification, channel modification, bank erosion, indigenous vegetation removal, exotic vegetation encroachment and water quality impairment. Most of the surrounding area was used primarily for grazing and livestock. Parts of the steep riverbanks have collapsed as a result of undercutting by floodwaters. The upper banks were nevertheless well vegetated. This segment was floristically more species rich than other river reaches assessed during this study. However, approximately 40% consisted of alien species. Segment 5 was provisionally determined as belonging to Class D, but since several criteria exceeded ratings of large, serious or critical, an additional negative weight was applied. The aim of this is to accommodate the possible cumulative effect (and integrated) negative effects of such impacts (Kemper *et al.*, 1999). Taking the latter into account this section of the Rietspruit was determined as belonging to Class E, i.e. the loss of natural habitat, biota and basic ecosystem functions is extensive (Figure 3).

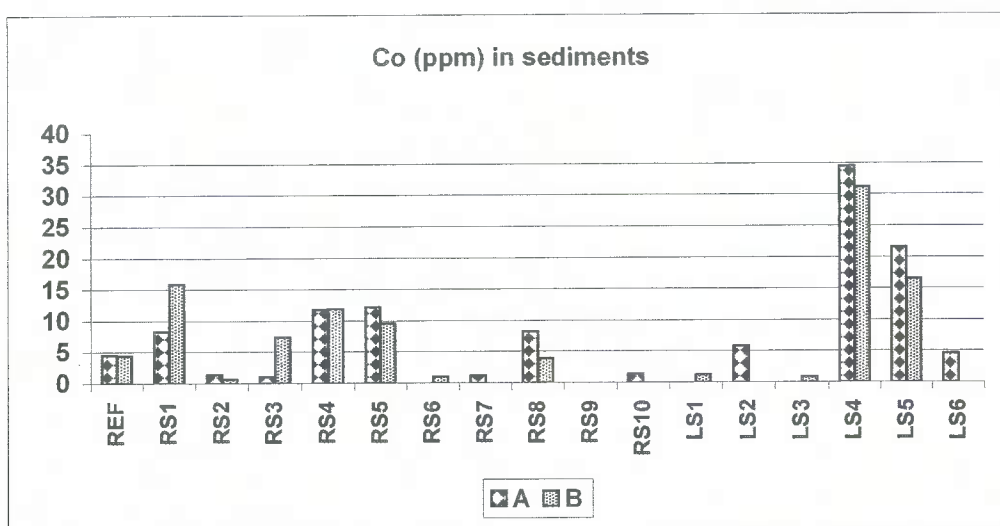
Figure Plate 2:
 Contaminant concentrations in sediments sampled from selected sites
 in the study area
 A = top depositional layer; B = second depositional layer

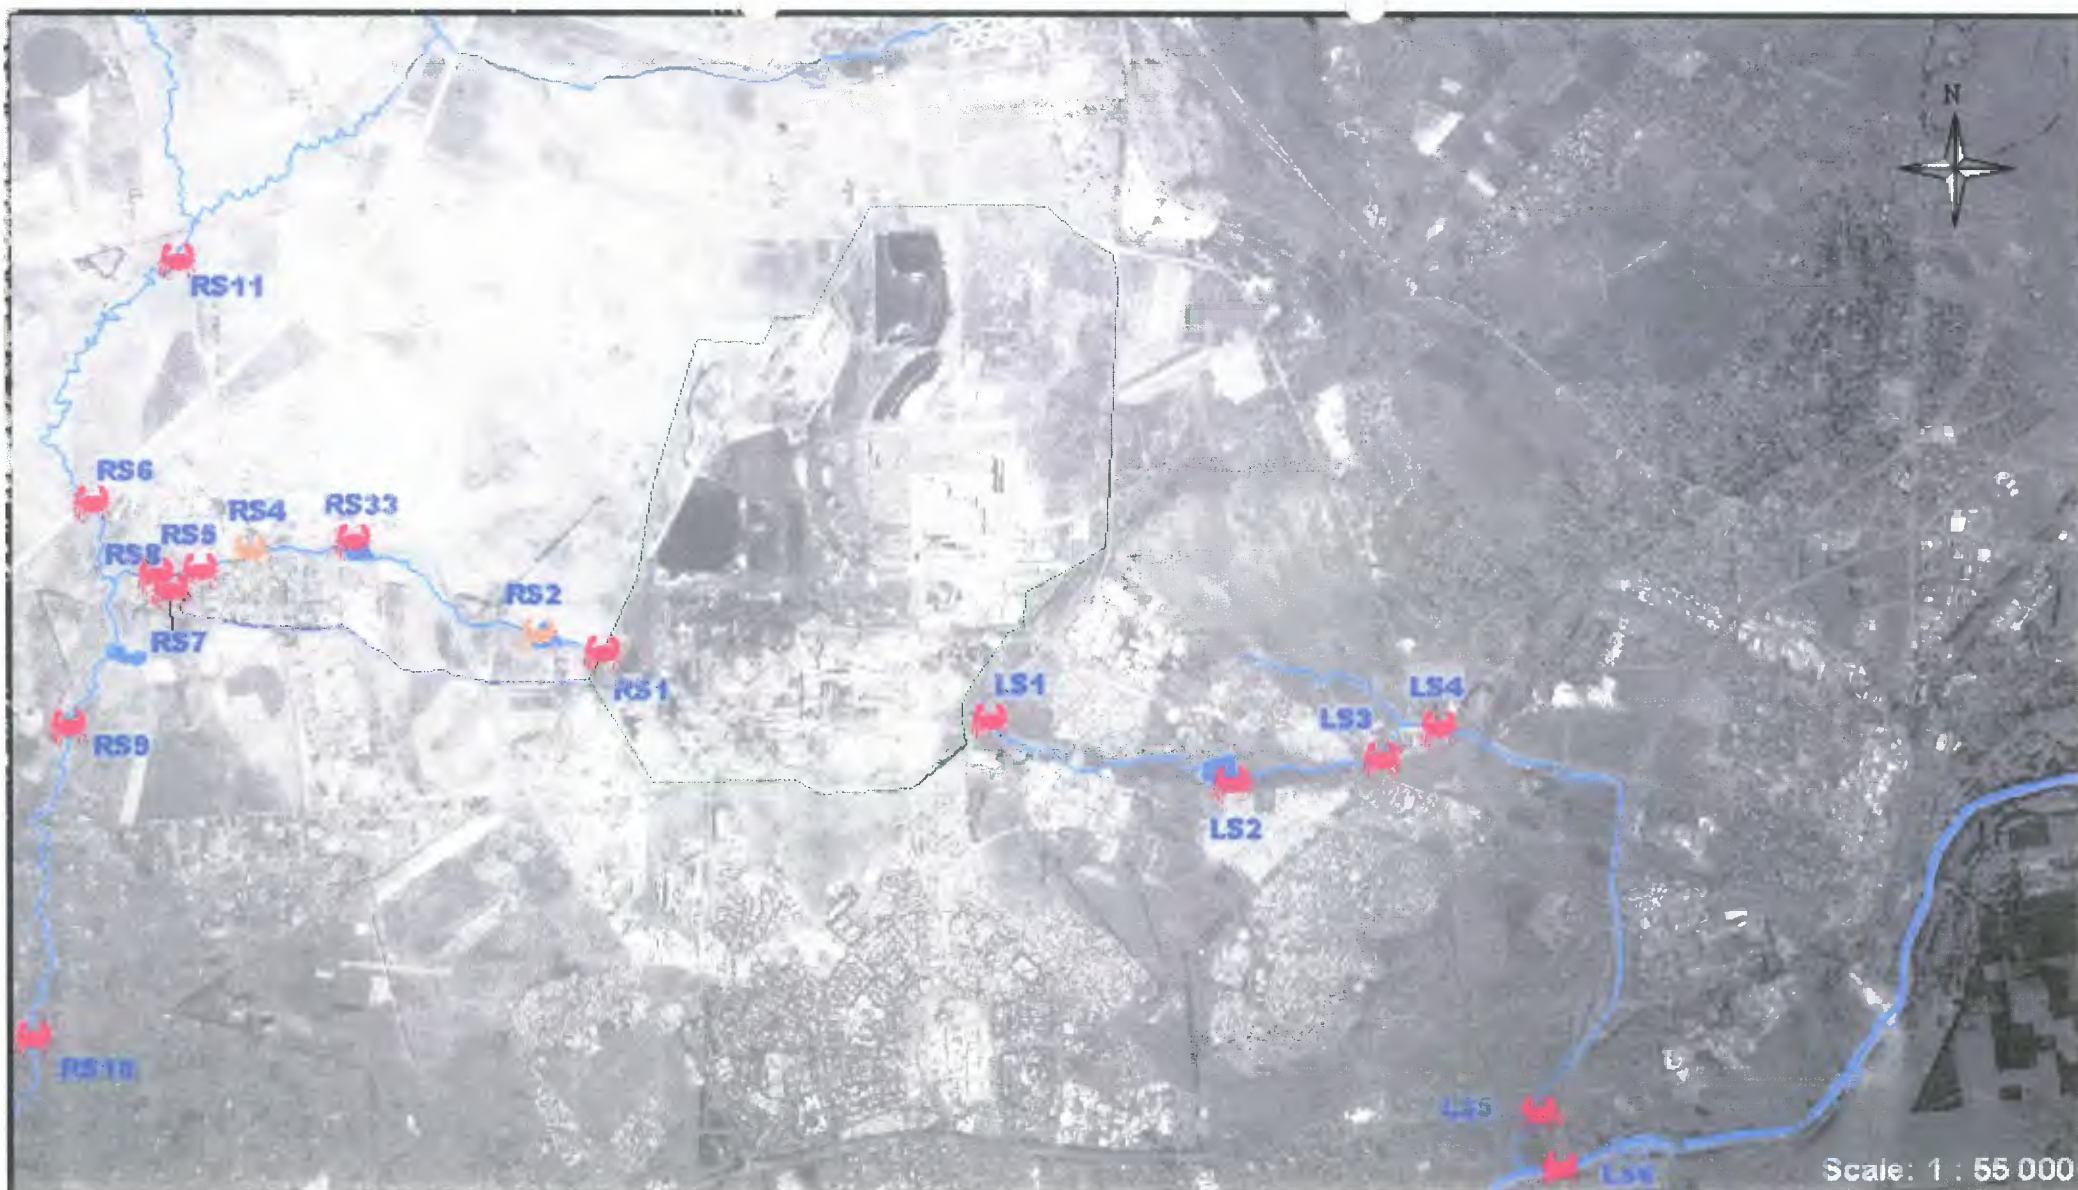
Figure 4: Present State Class at selected sites in the study area, based on SASS results

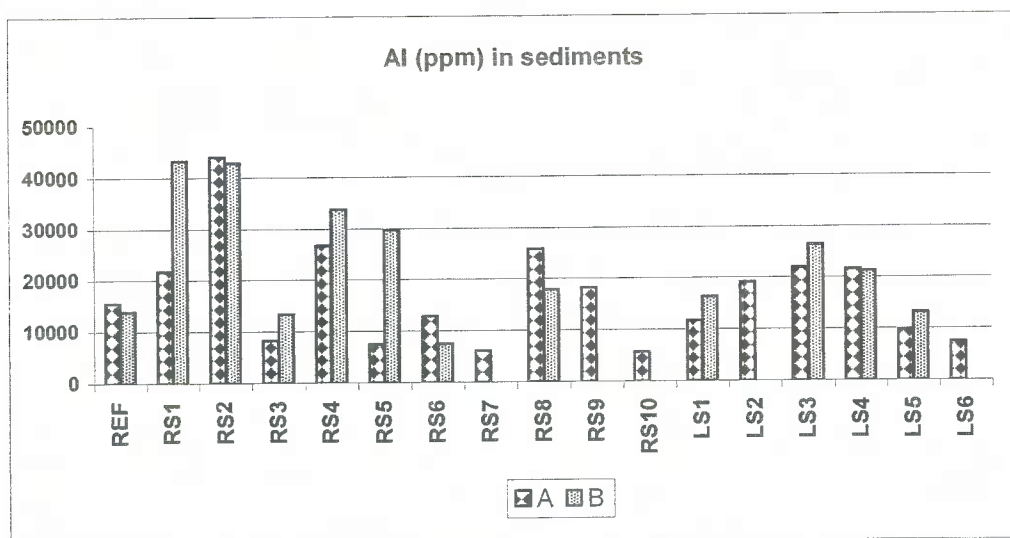
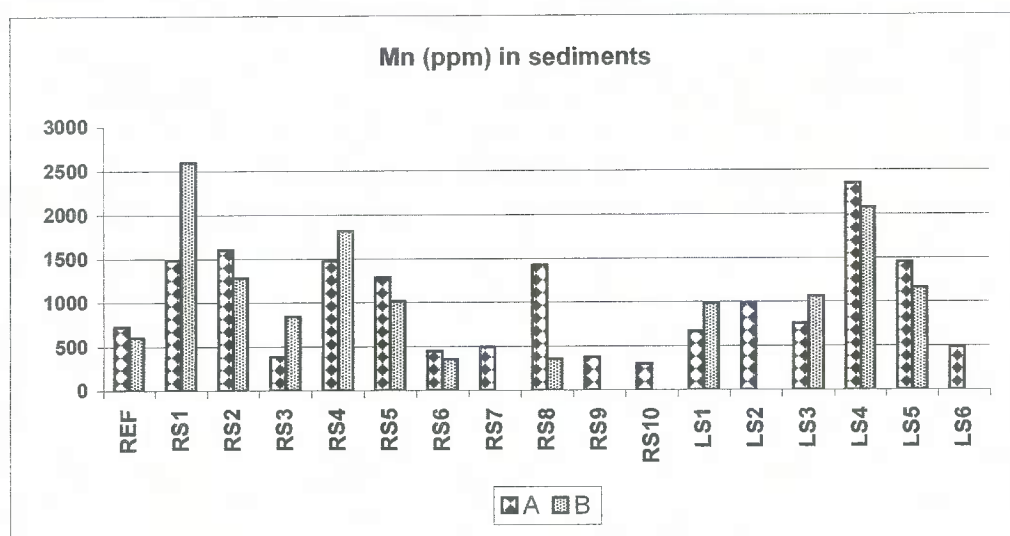
Figure Plate 5:
 Contaminant concentrations in sediments sampled from selected sites
 in the study area
 A = top depositional layer; B = second depositional layer

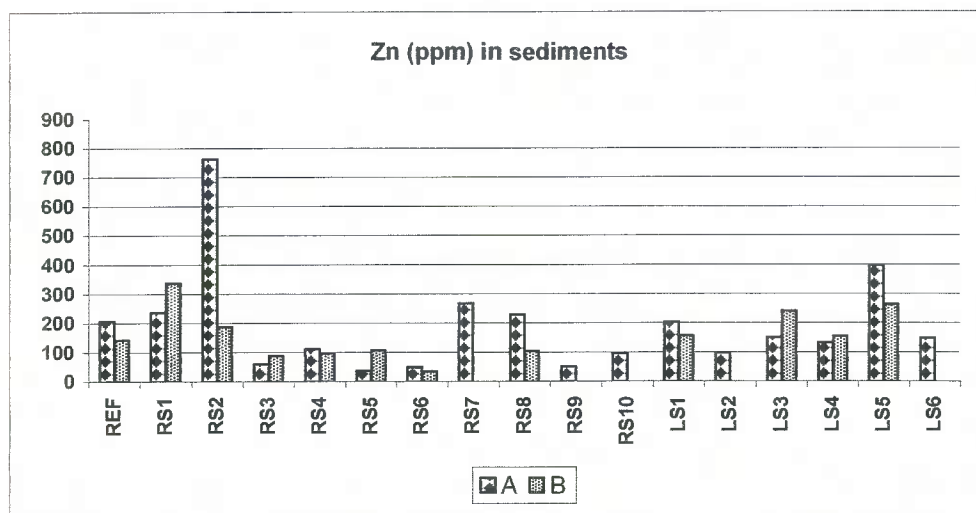
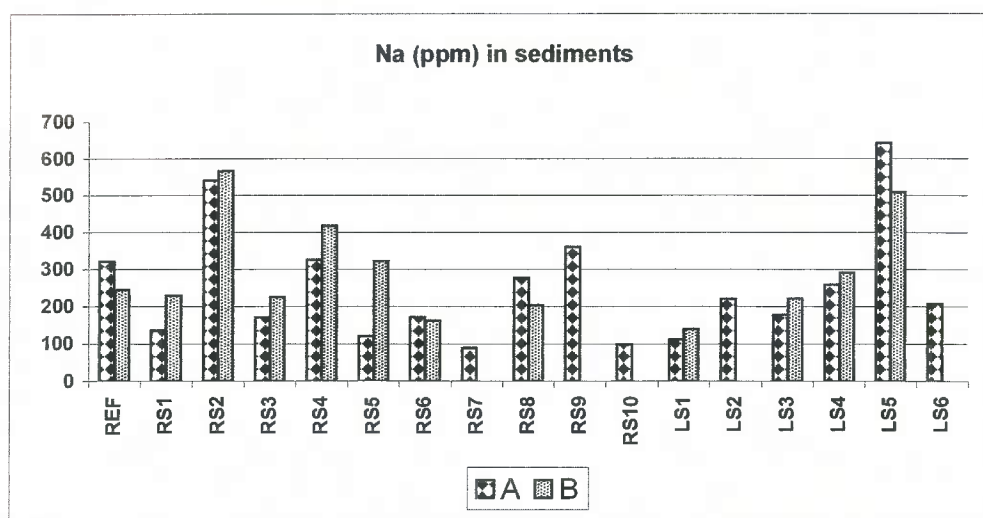
Figure Plate 6:
 Contaminant concentrations in sediments sampled from selected sites
 in the study area
 A = top depositional layer; B = second depositional layer
