ArcelorMittal

Vanderbijlpark Works

Environment: Summary Report December 2014

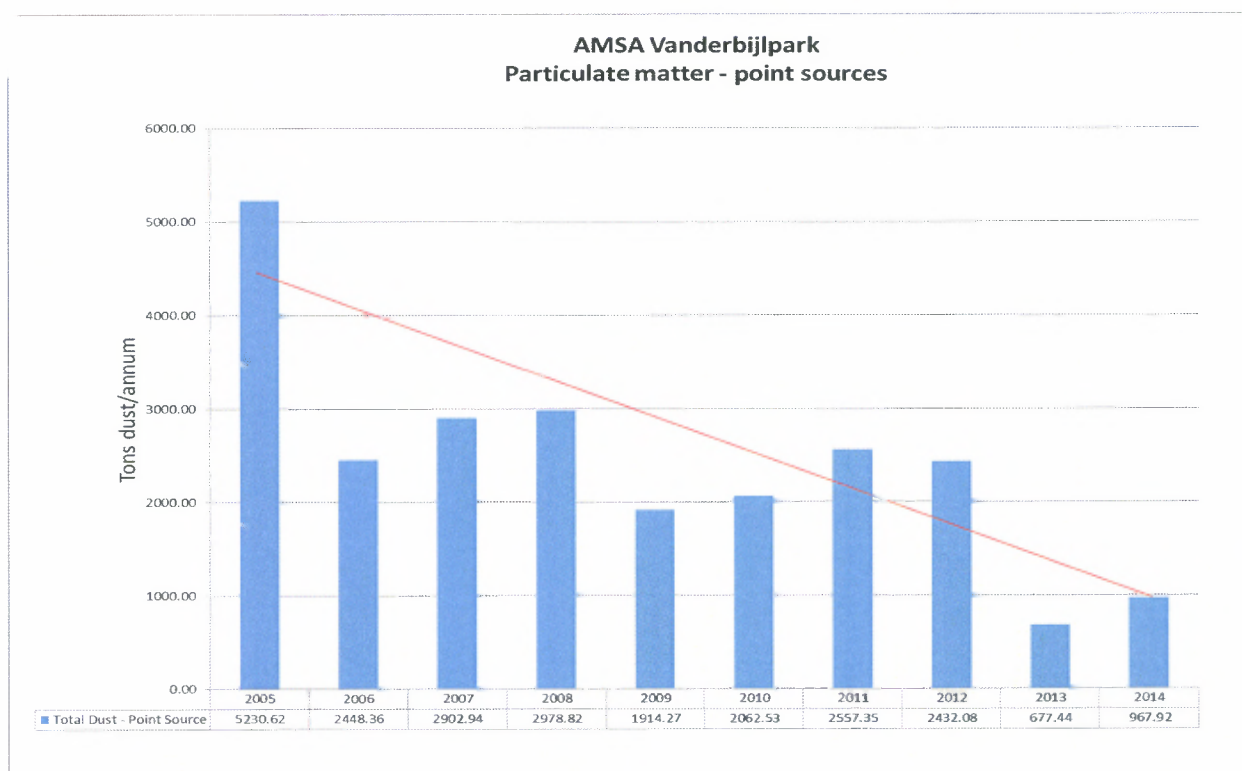
Figure 1: 82% reduction in terms of particulate matter emitted from point sources (2014 is a projected figure).

AMVW has achieved an 82% reduction in emissions (dust) to air (Figure 1) over the past 9 years, with 2005 considered to be the baseline, through various interventions (Table 2 & 3).

In summary, the reduction in point source emissions has been achieved through the implementation of the following actions:

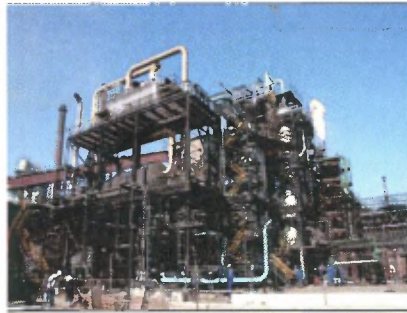
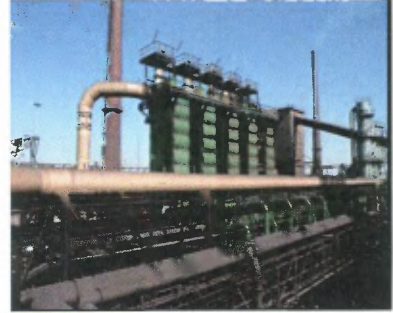
- 2011 to 2012: The Sinter bag house is one of various projects that were commissioned in 2012 as part of our planned improvements. The particulate emissions from the Sinter main stack were the single biggest point source on site. The installation of abatement equipment to capture emissions from the stack was finalized and commissioned in October 2012. This project reduced the dust load for the Sinter plant by 93%.

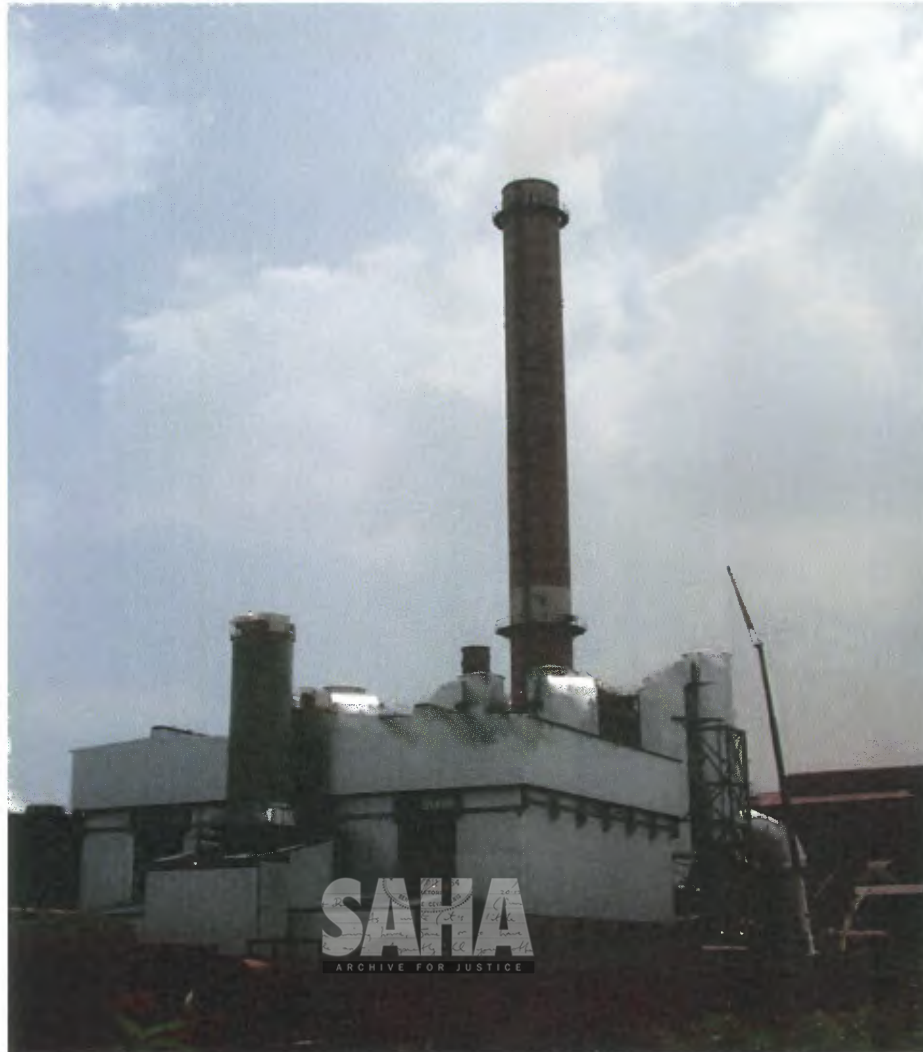
Sinter Clean Gas Project

Construction of the dry scrubbing technology commenced in October 2008. This project assisted AMVW to achieve the significant emission reductions as illustrated in Figure 1. Construction of the Sinter dry scrubbing equipment amounted to a total cost of roughly R 256 million.

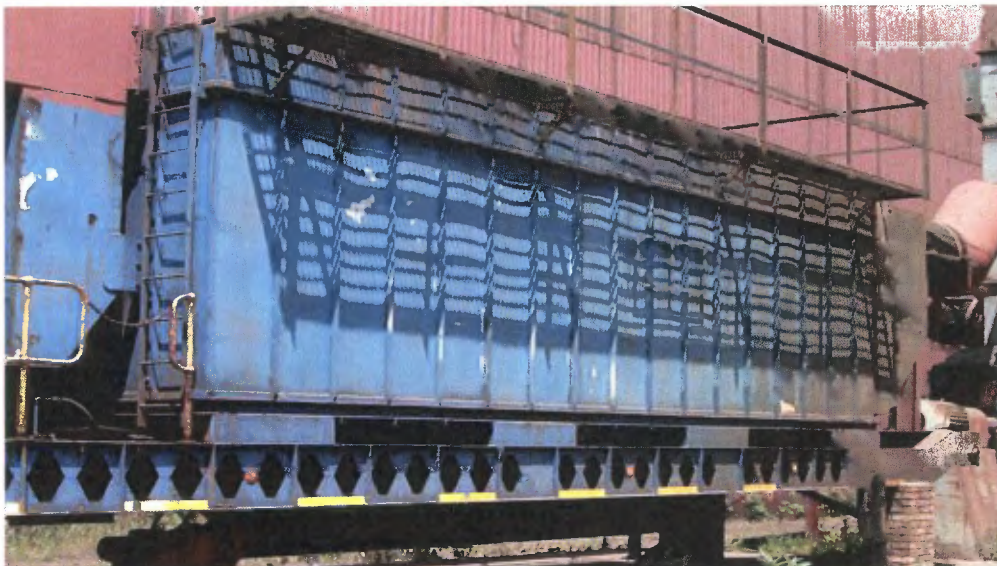
2012: Installation of bag house at the Foundry to supplement removal of particulates from emissions

Foundry Cyclone Upgrades

An additional bag house was commissioned at the Foundry in 2012 which contributed to a 76% reduction in the point source emissions from this plant.

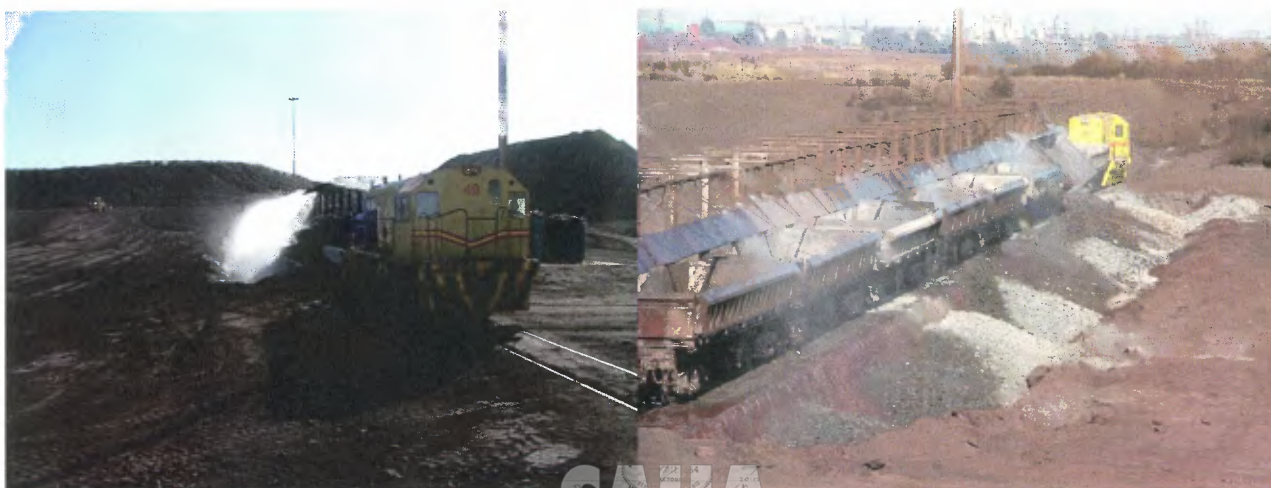
Upgrade of existing tip station in 2012 by enclosing Tip B by 50% and installation of water-mist sprayers

A dust suppression system has been installed at the waste disposal site that suppresses dust when the waste material is off-loaded at the tip station before disposal. The dust suppression system is effective in reducing dust emissions during the handling of waste materials. The system is however not as effective when handling very fine dust material like DR Dolochar waste. The dust suppression system will be further improved in future.

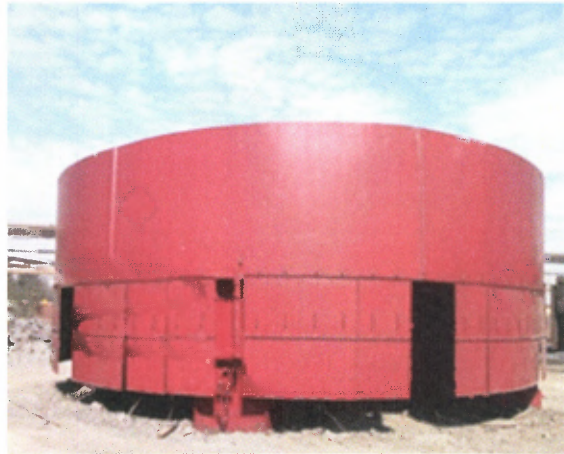
Lancing Booths

Lancing is a process used for cutting oversize steel into smaller manageable fragments which can be re-used in the steel making process. In an effort to reduce the fugitive emissions from the lancing activity a new lancing hood has been designed and installed with an upgrade of extraction points. Additional mobile bag filter units were also purchased for the lancing of steel.

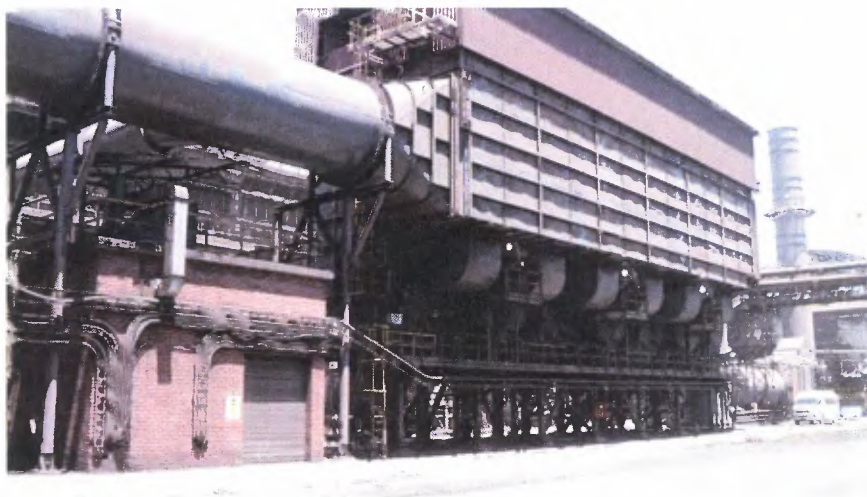
The fugitive dust is captured by the new extraction system

- The bag house will ensure compliance with all future Air Quality Act requirements.
- Fugitive emissions for AMVW will be reduced by 2800 tons/annum

- The Blast Furnace D Stock house was a source of fugitive dust emissions at AMVW. A significant reduction will be achieved from now onwards by an improvement in the dust collection efficiency, and the abatement of fugitive dust emissions at both the Stock house and furnace top.
- This project will achieve further emission reductions as planned by AMVW from 2014 onwards.
- Project commissioning date November 2014.

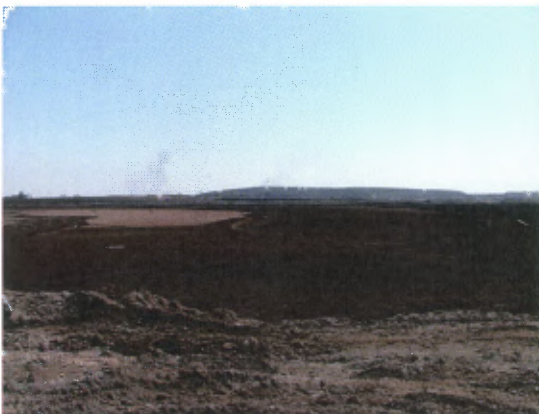
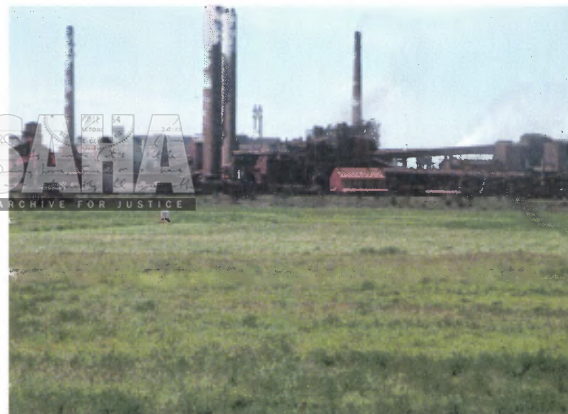
Rehabilitation of the facility was completed in 2012, with open, indigenous veld as the subsequent end-use. A significant portion of time was expended on getting the dam dry and allowing the natural effect of the micro-organisms to take its course in order to achieve prescribed remediation targets.

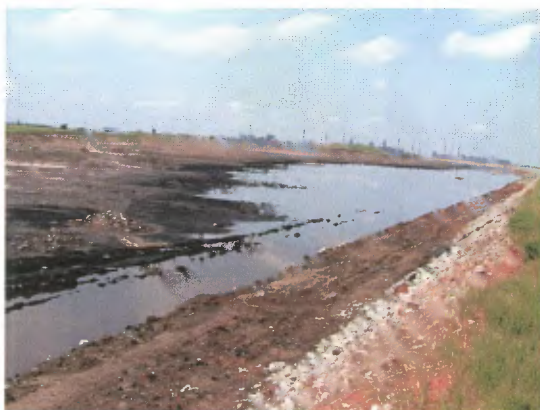
Dam 3 before rehabilitation

Due to the success of the in-situ bioremediation undertaken at Dam 10, the same remediation methodology was exercised at the Maturation Ponds. Dam 3 has been fully rehabilitated. It is expected that the remediation of Dam 2 will be completed by Q1 2015, followed by Dam 1. The slight delay in completion of rehabilitation of the entire facility is attributable to the time taken for the natural decomposition processes effected by the micro-organisms.

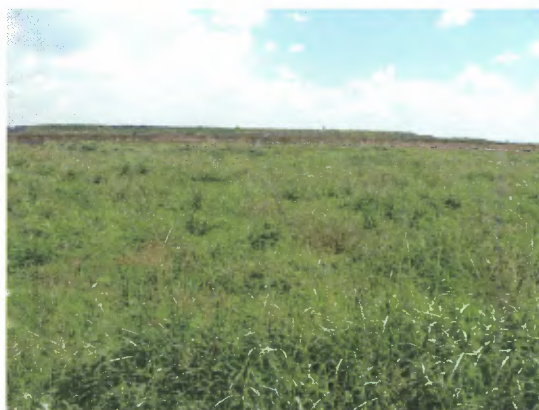
Dam 3 after rehabilitation

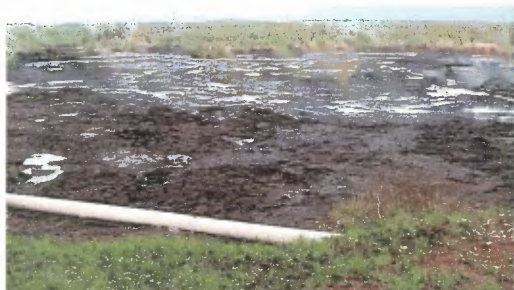
CETP 2 before rehabilitation

CETP 2 was successfully remediated in 2012. The residue in CETP 1 has been placed in windrows in preparation for bioremediation to commence in 2015.

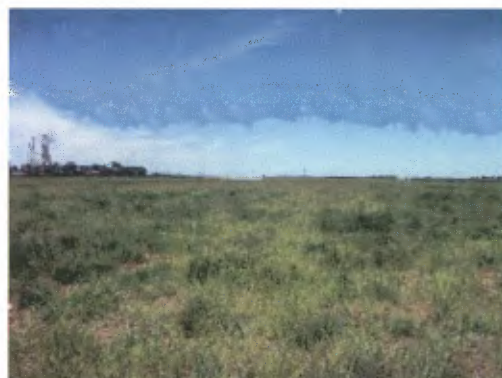
CETP 2 after rehabilitation

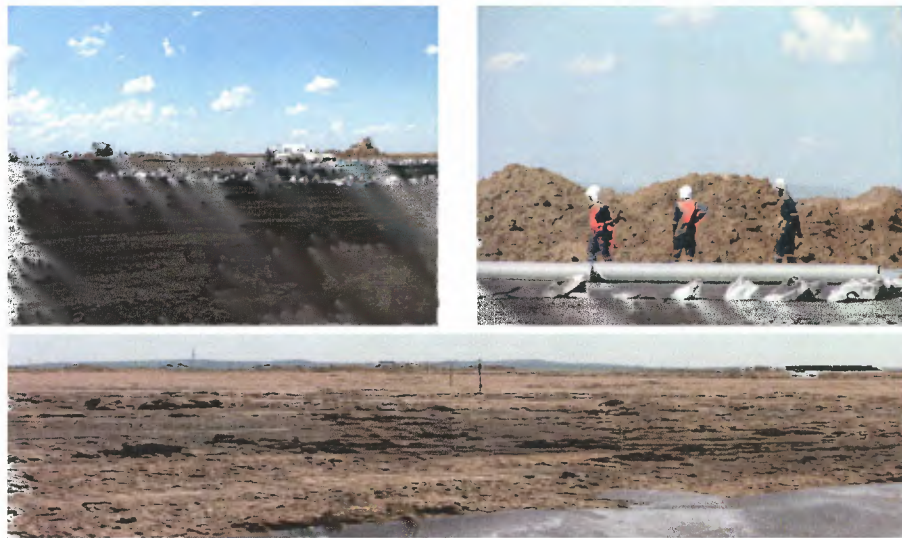
Capping process – Phase 1/2 &3

This process entails the laying down of a series of clay layers which are subsequently compacted and overlain by a plastic liner. The next step in this rehabilitation process is to cover these layers with soil and vegetate the required area with indigenous grass species. To minimise soil erosion, the site was carefully sloped, stepped and equipped with drainage galleries to direct storm water away from site.

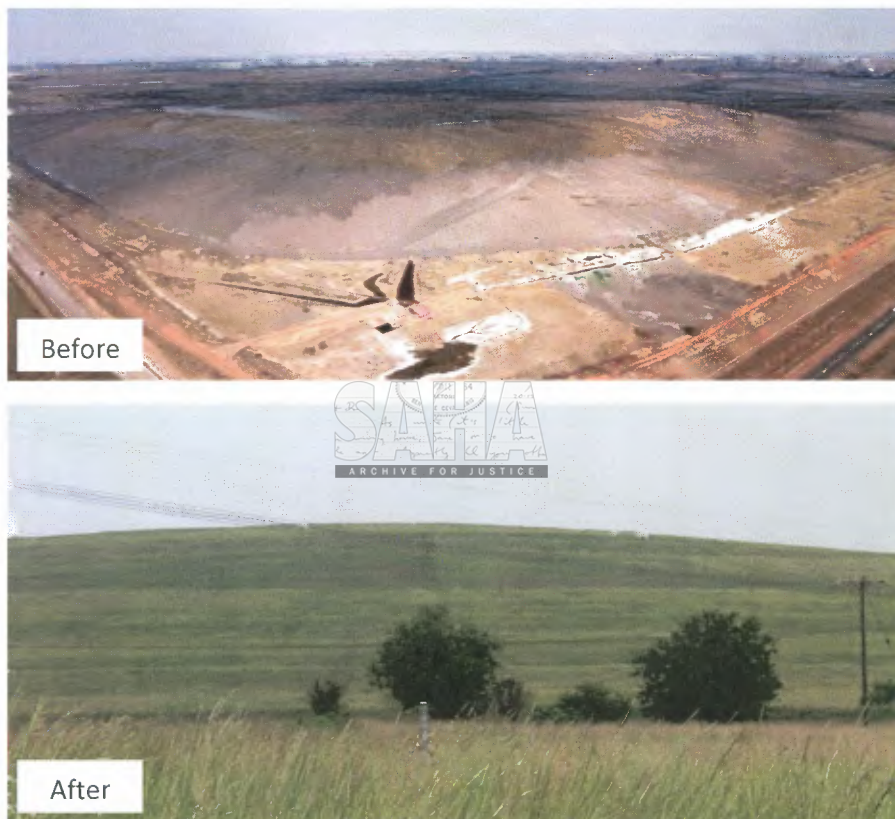
Phase 1: Remediation – Before and After

Phase 1: (55 ha) of the remediation of the old waste disposal facility commenced in September 2009 and has been successfully completed in 2010. Disposal operations at the old waste site ceased on 31 December 2010 and sufficient vegetation has been established in 2011.

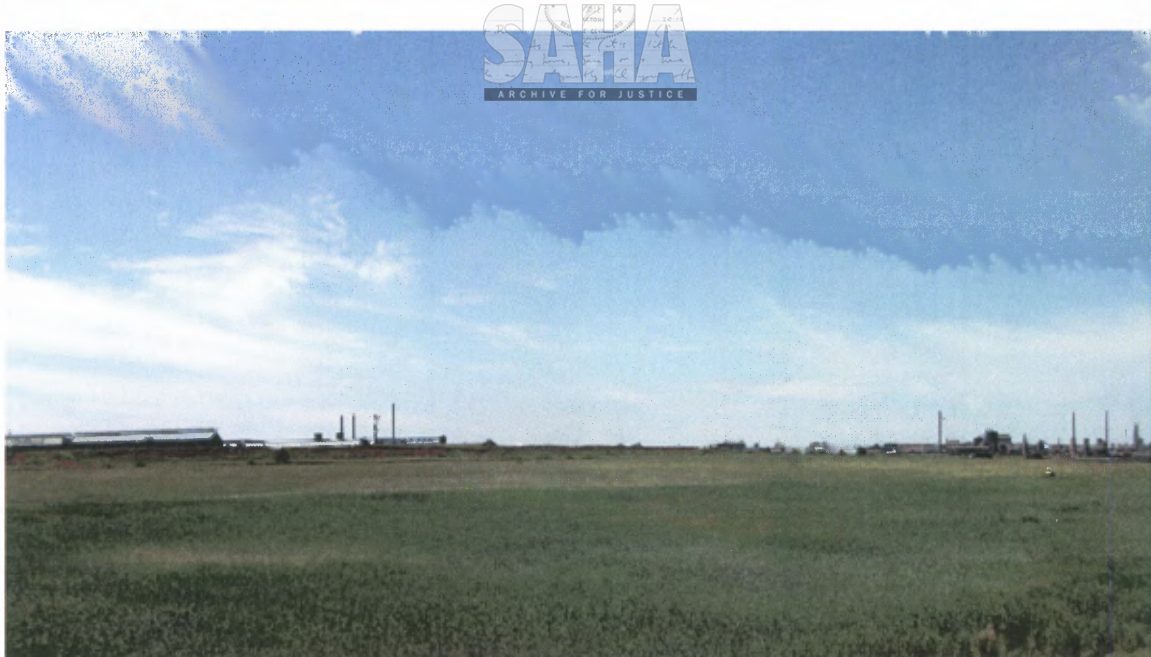
Area west of Maturation Ponds – sloped and vegetated

- Removal of any material that posed a risk to contamination of storm water
- Vegetation of disturbed areas through hydroseeding
- Sloping to prevent ponding

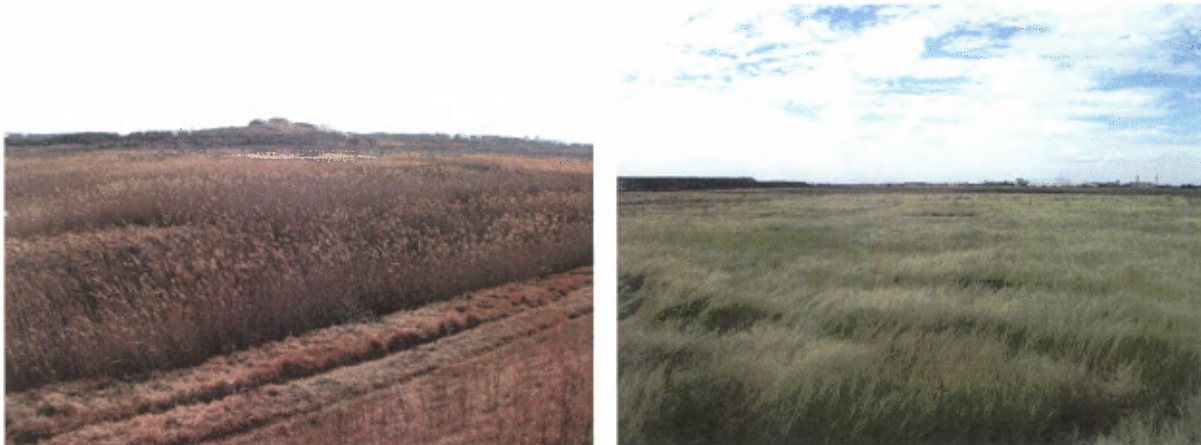
Before (Old By-products Area)

After (Old By-products Area)

To date, approximately 178 ha of peripheral areas have been cleared of scrap material, redundant by-products and residues to mitigate potential impacts on the groundwater reserve and improve surface water run-off qualities. In addition, these areas have been sloped and vegetated to further mitigate impacts associated with barren areas, including fugitive dust emission reduction.

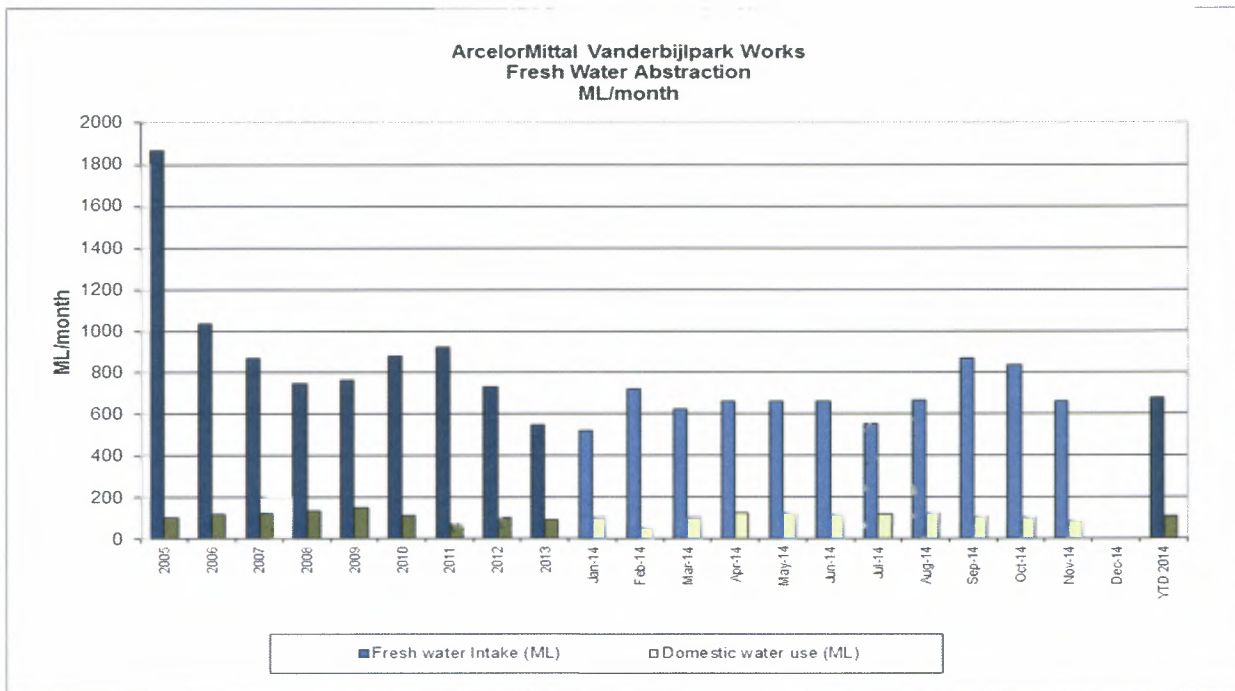
Figure 2: Reduction of water abstraction

From 2004 to 2005 AMVW upgraded the Central Effluent Treatment Plant (CETP) and the Main Treatment Plant (MTP) to institute Zero Effluent Discharge (ZED) from the Works. In addition this project assisted AMVW to achieve a reduction of water abstraction volumes of 53% (graph 2) compared to the 2005 baseline. Consequent to water balance issues, AMVW has encountered problems to sustain ZED during certain periods, which prompted additional upgrades. As a result of operational changes an upgrade was required during 2012 and included the installation of an additional quality filtration system at a cost of R1 360 000 per month. Primarily due to the shutdown of Electrical Arc Furnace plant, AMVW requires a further upgrade to the MTP plant (R90 million) in 2015 in an attempt to reinstate and maintain its ZED status.

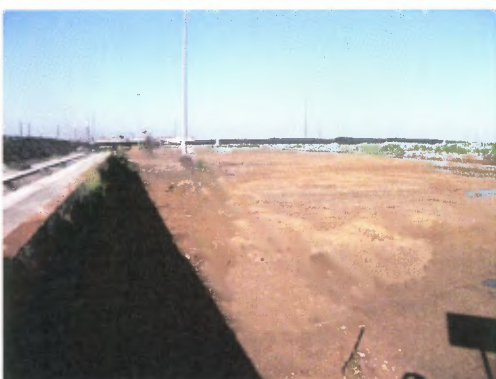
Area preparation completed for new by-product storage areas

To improve by-product storage practises on site, AMVW has invested in the establishment of new storage facilities. The proposed new storage areas, currently in the construction phase, have been designed to conform with best practice and regulatory guidelines. These areas will be lined, bunded and equipped with drainage facilities. The new storage areas will significantly reduce the potential impact on the environment.

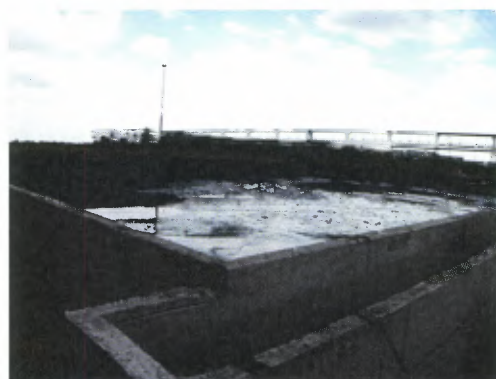
Fine mill scale drying area

In line with the waste management principle of “disposal as the last resort”, AMVW has found a market for the mill scale generated on site. Mill scale is formed on the outer surfaces of steel plates or sheets during rolling processes. The current mill scale storage area will be relocated to the new by-products storage area in the near future to reduce the operational footprint of the combined by-product facilities.
